Amesbury Middle School- Roof Assessment Report
220 Main Street, Amesbury MA 01913

To: Mr. Matthew Bennett / Haverhill Housing Authority
Fm: Matthew Nolan / Tremco Roofing
Dt: December 8th, 2021

Re: Amesbury Middle School- Roof Assessment Report

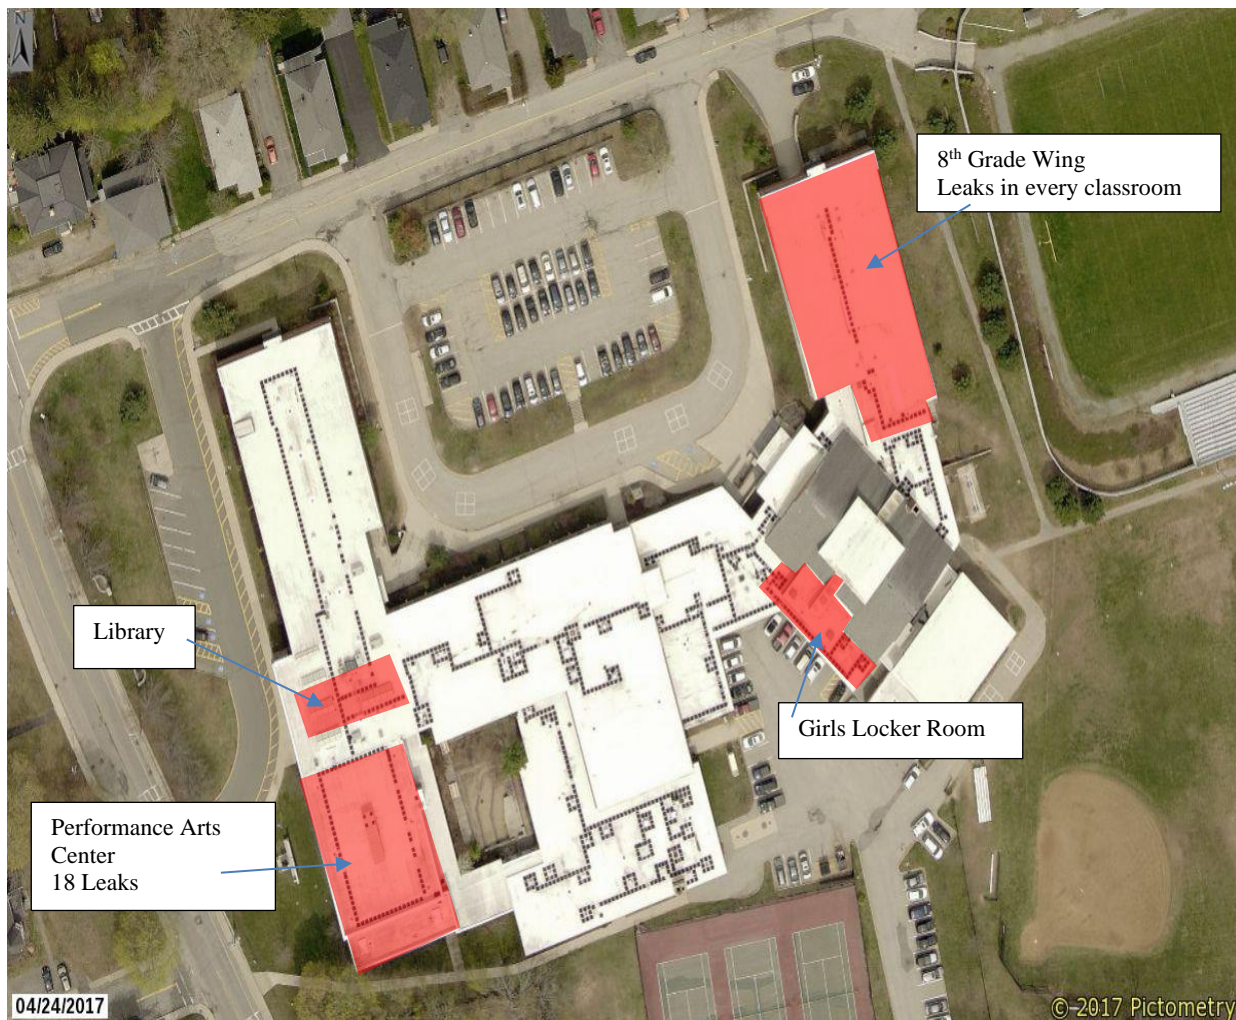
Aerial Image #2: Outlined areas on low sloped roof where membrane was witnessed deteriorating, and leaks reported. The areas also coincide with locations of moisture intrusion noted on infrared scan.

When considering repairs effort for the Middle School as a temporary/bridge effort as budgeting is found for full replacement, the roof areas outlined in Aerial Image #2 should be prioritized. Due to the condition of the membrane in the areas outlined, a considerable repair effort should be considered for each location.

- A fluid applied repair solution is recommended for repair efforts. In order to provide a 2–5-year fix, a material called AlphaGuard MT Base Coat should be considered. This material requires that the membrane is cleaned, primer installed, and then urethane base coat material applied to selected locations at 3 gallons per 100 sq. ft. Reinforcement fabric is installed in the wet base coat, providing superior, self-terminating waterproofing.

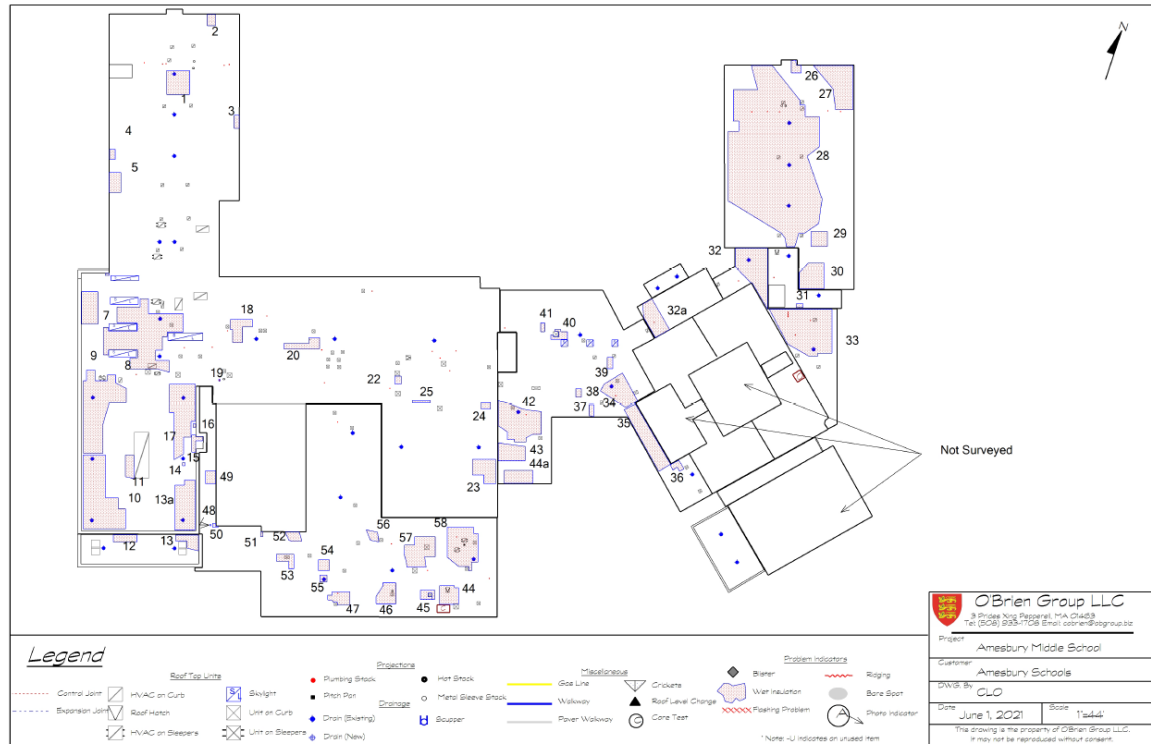
- Performance Arts Center- The PAC has reportedly 18 active leaks ongoing at this time. The upper section has 10, while the lower area has 8. The TPO membrane is deteriorating at this time and significant moisture was noted on the infrared scan drawing (provided below- Model 1).

Model #1: Drawing of compromised insulation by the O'Brien Group.

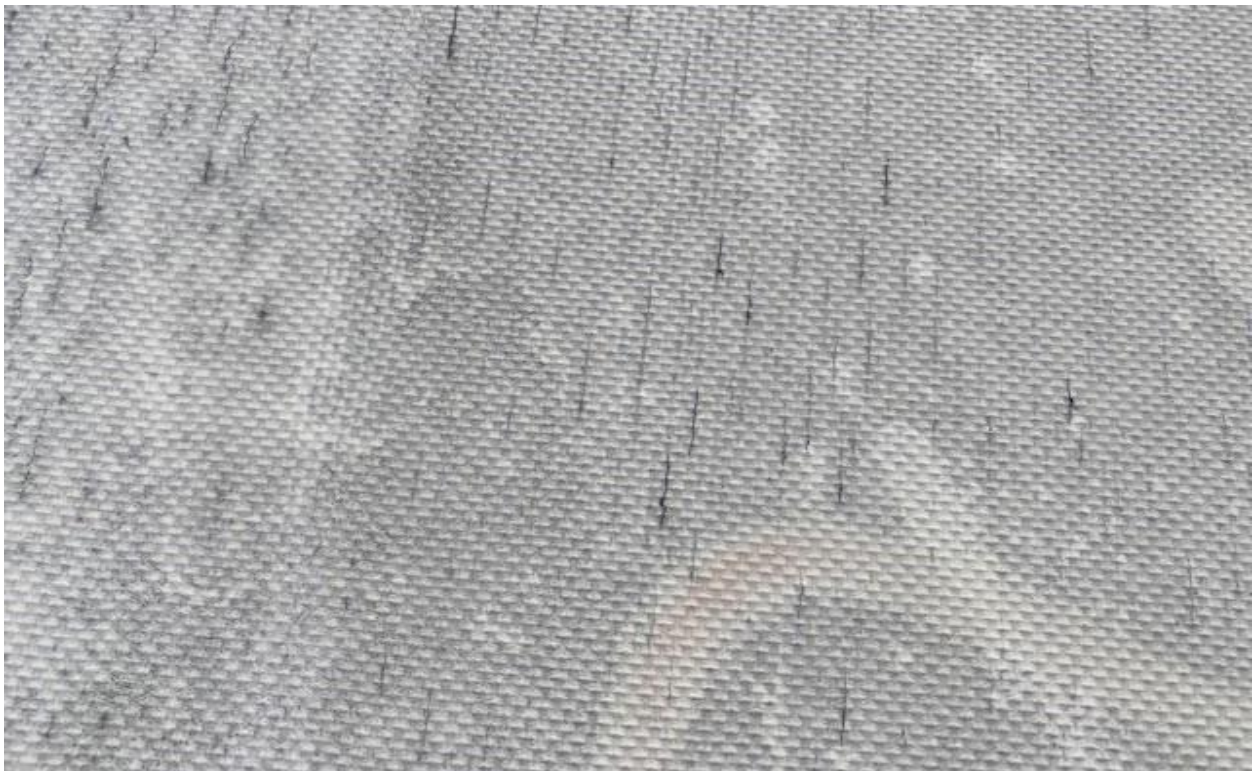
- 8th Grade Wing- The second floor on the 8th Grade wing reports leaks in every classroom. TPO membrane was found to be deteriorating over the entire roof area. Previous repairs have been made on this wing. Due to unadhered patch, enhancements to seams were made at patch in 2019.

Photo #2: The TPO membrane installed on the 8th Grade Wing is brittle and cracked. The membrane will continue to deteriorate if left exposed.

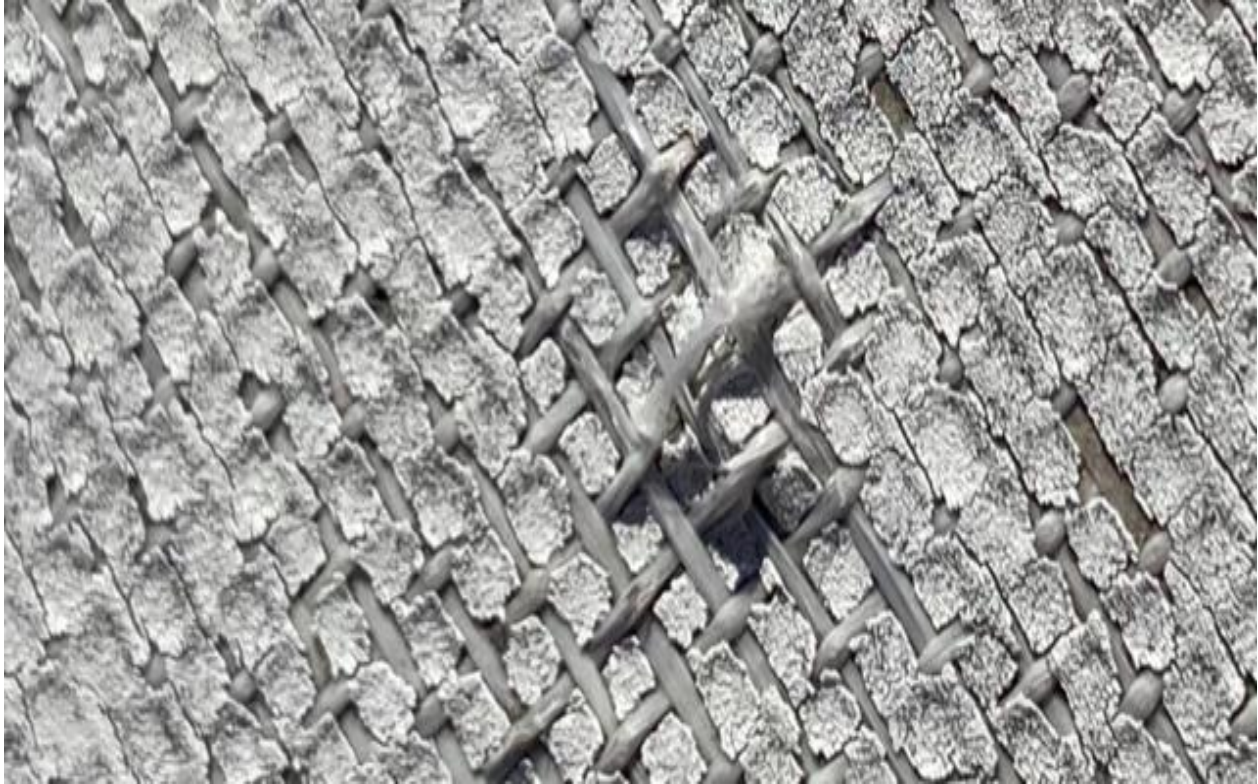
Photo #3: Close up photo of the deteriorated TPO membrane.

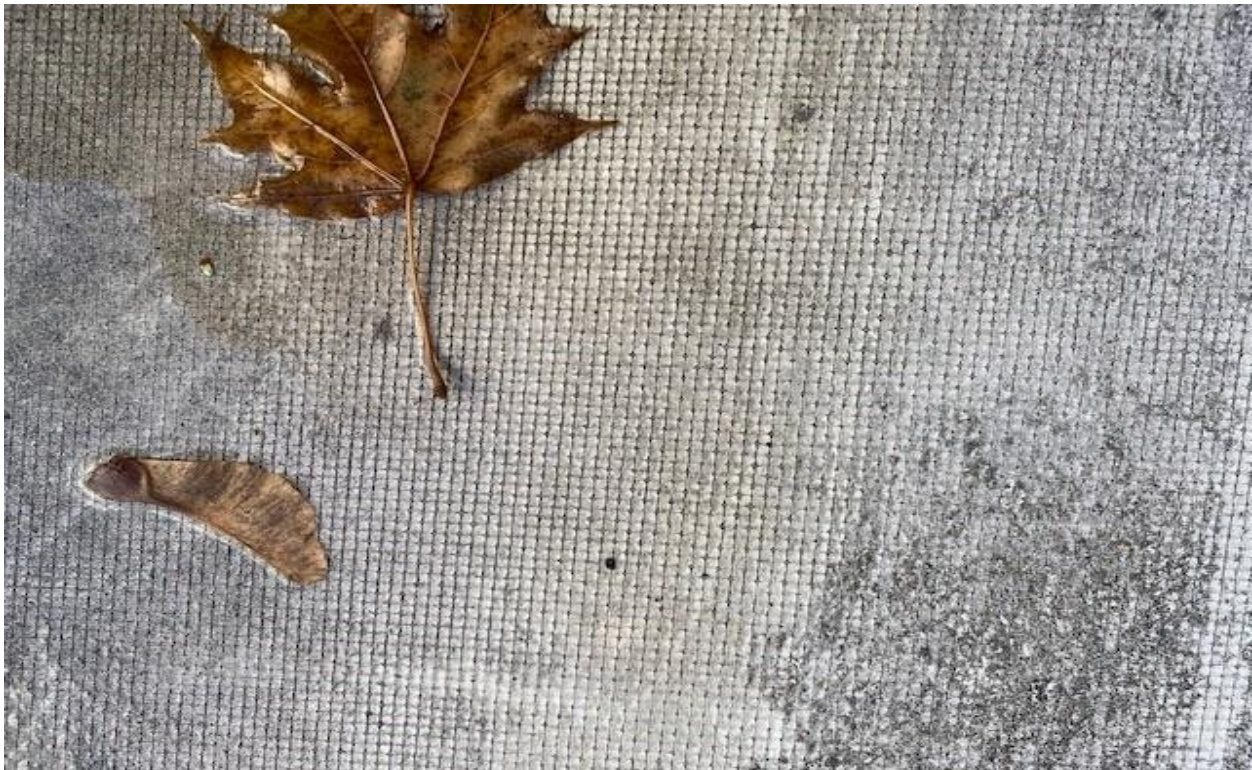
- There are large sections of the membrane where the scrim of the TPO membrane is exposed. The scrim is the material that stabilizes the thermoplastic materials used to create the TPO waterproofing sheet. The thermoplastic waterproofing is installed over the scrim. Once the scrim is exposed, water travels on the scrim and bypasses the sheet.
- There are sections of the TPO membrane where it is so brittle, you can insert your finger through the membrane with very little effort. Typical foot traffic will cause additional cracking of the membrane, especially in colder weather.
- All locations where Versico black rubber walk-pads were installed on the roof have expedited the deterioration process of the TPO membrane. There are long splits that border the walk pad areas.

Photo #5: Overview of the deteriorating membrane on the low roof on the PAC. Simply running your finger over the membrane will expose the scrim of the waterproofing system.

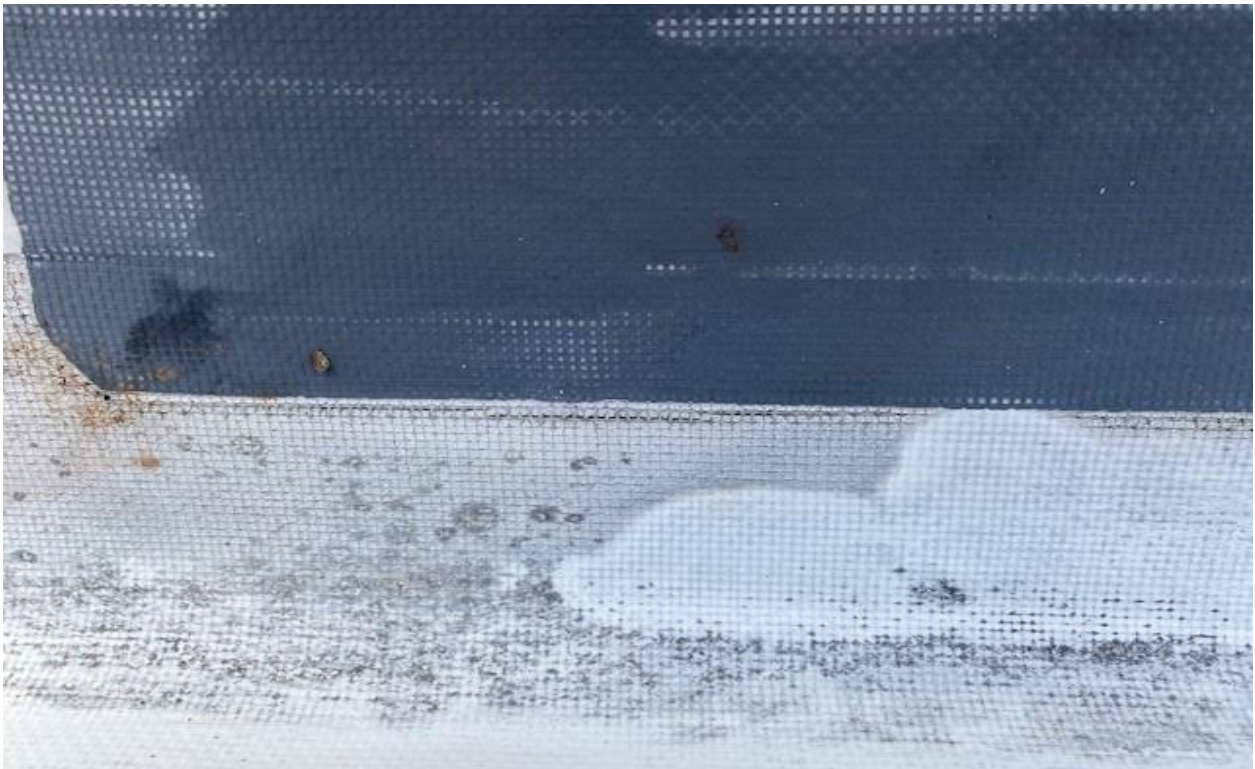
Photo #6: Overview of the deteriorated membrane on the upper roof of the PAC.

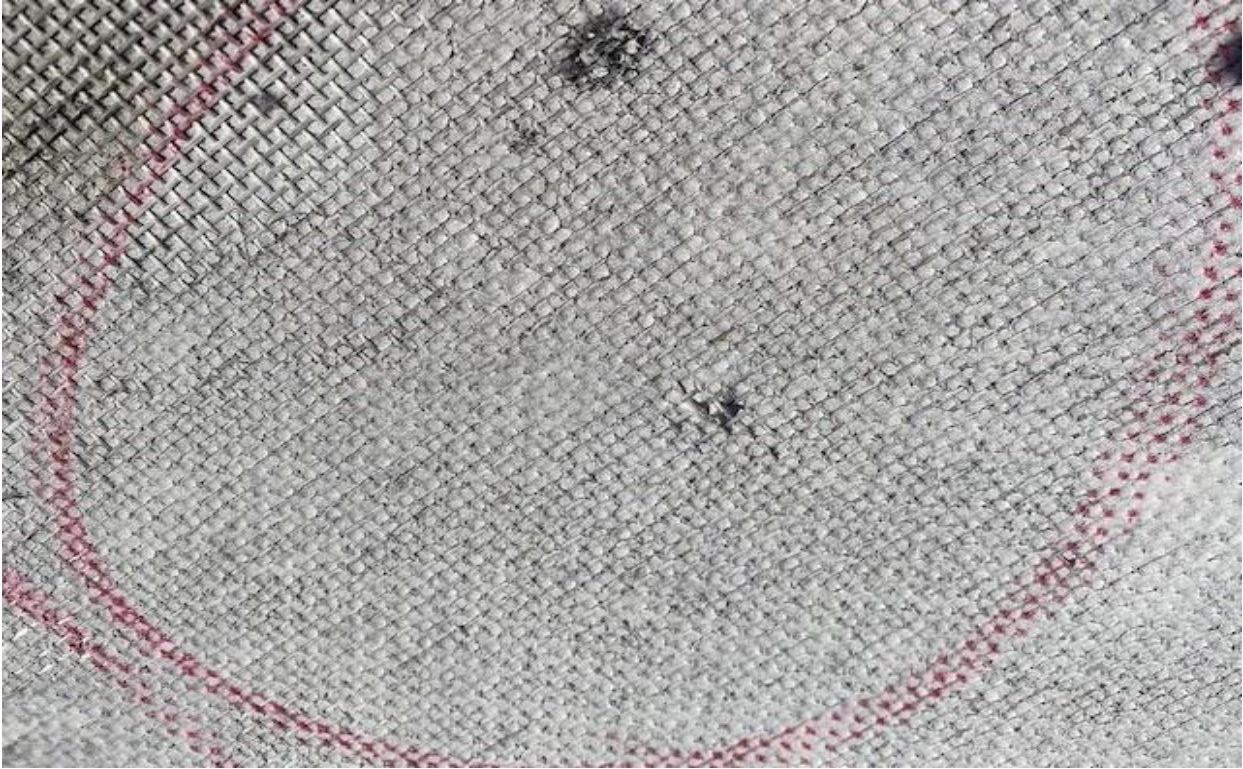
Photo #7: Overview of the deteriorated membrane on the upper roof of the PAC. The membrane is so brittle, that typical foot traffic can puncture the membrane.

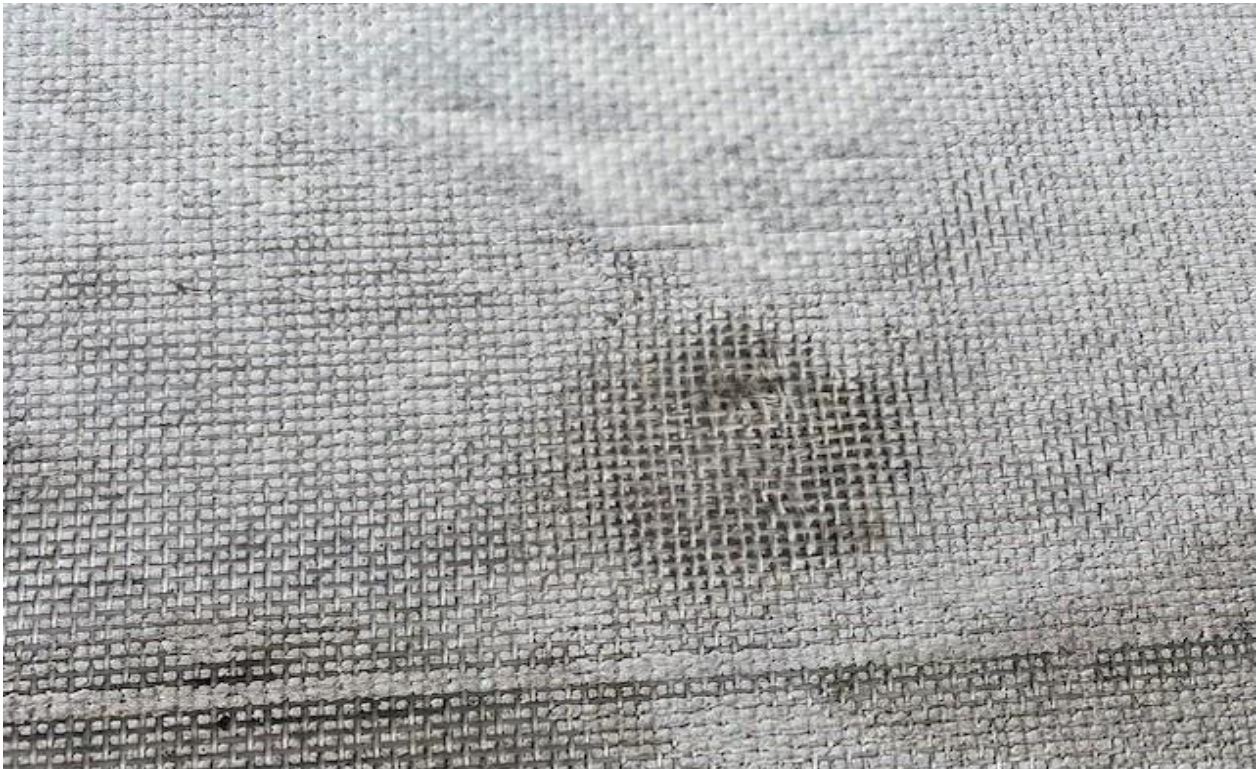
Photo #8: The membrane is badly deteriorated and will continue to fall apart if not treated with waterproofing.

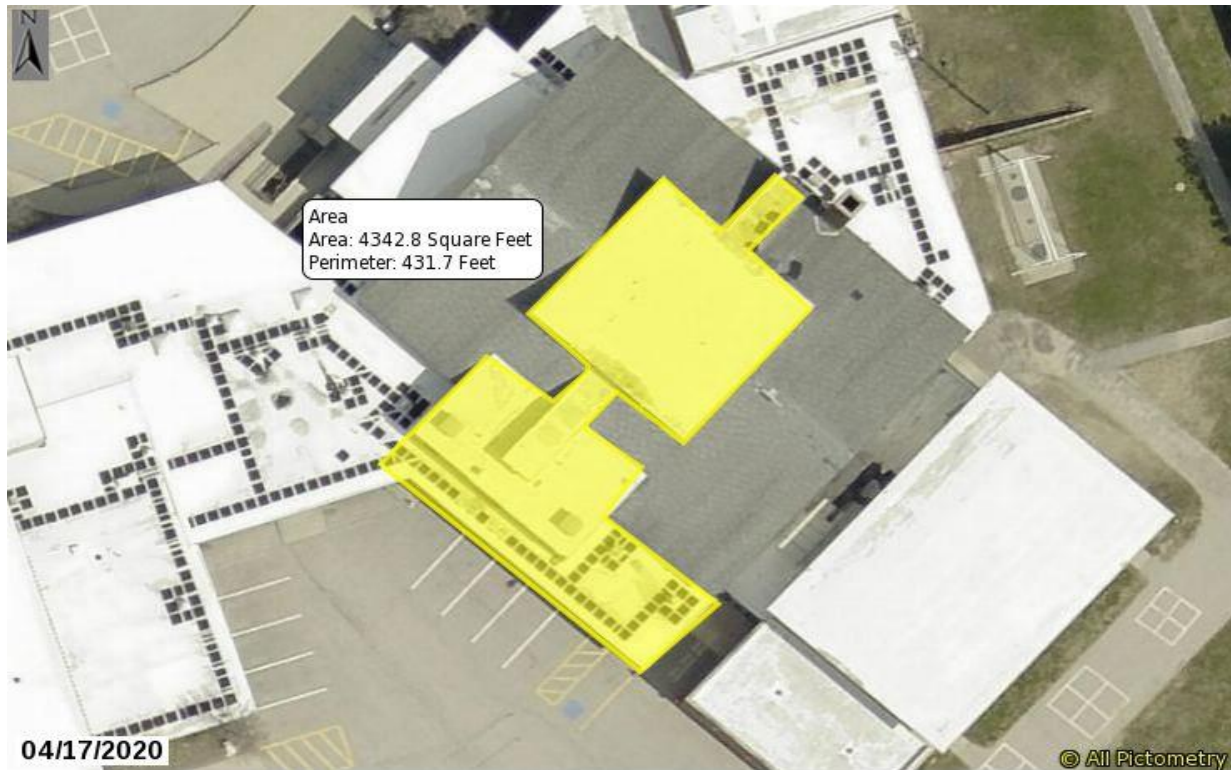
- Gym & Girls Locker Room- There is a significant leak over the Girls Locker room. There is low sloped roof area above the locker room that is ponding water. There are sections of membrane that have large splits. There are deteriorated shingles which is likely contributing to deteriorated structural decking & moisture intrusion concerns.

Aerial Image #6: Overview of the low sloped roof areas over the Gym that are ponding water, have deteriorating membrane, and are likely contributing to moisture intrusion issues inside the facility.

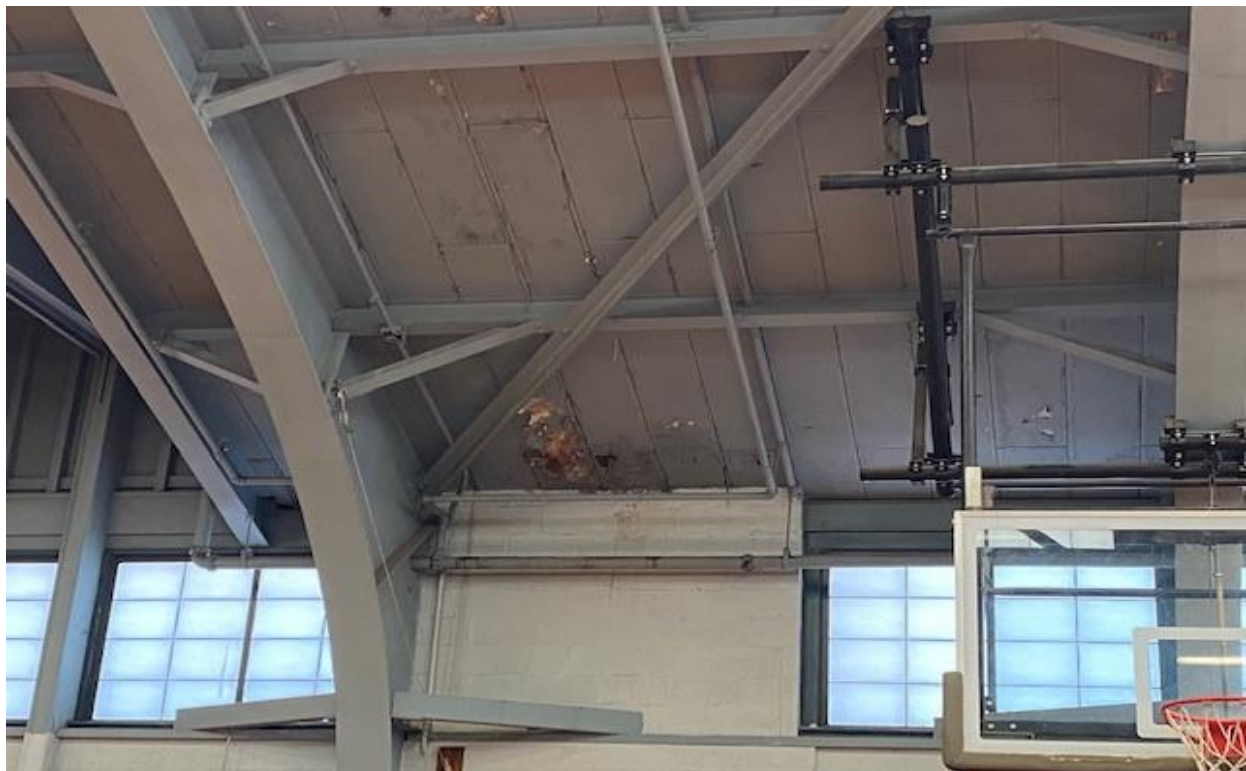
Photo #9: Internal moisture damage inside the gymnasium.

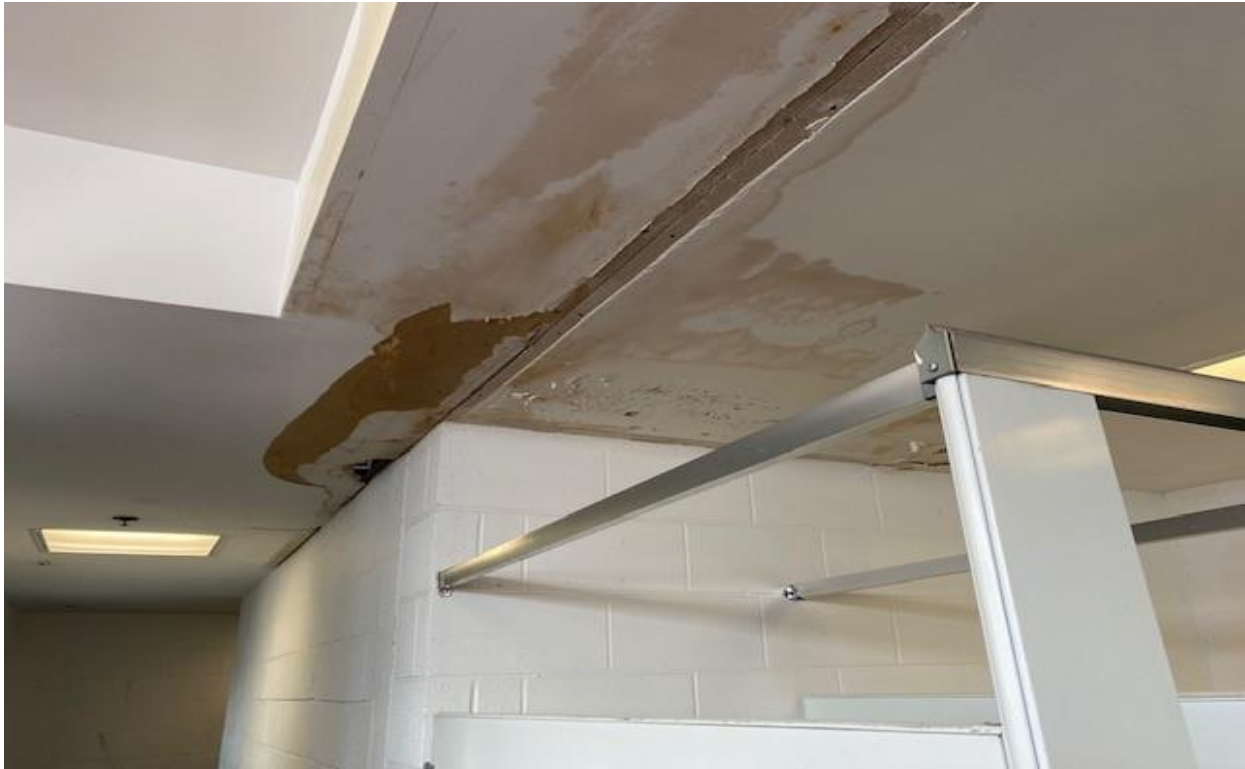
Photo #10: Internal moisture damage inside the girl's locker room.

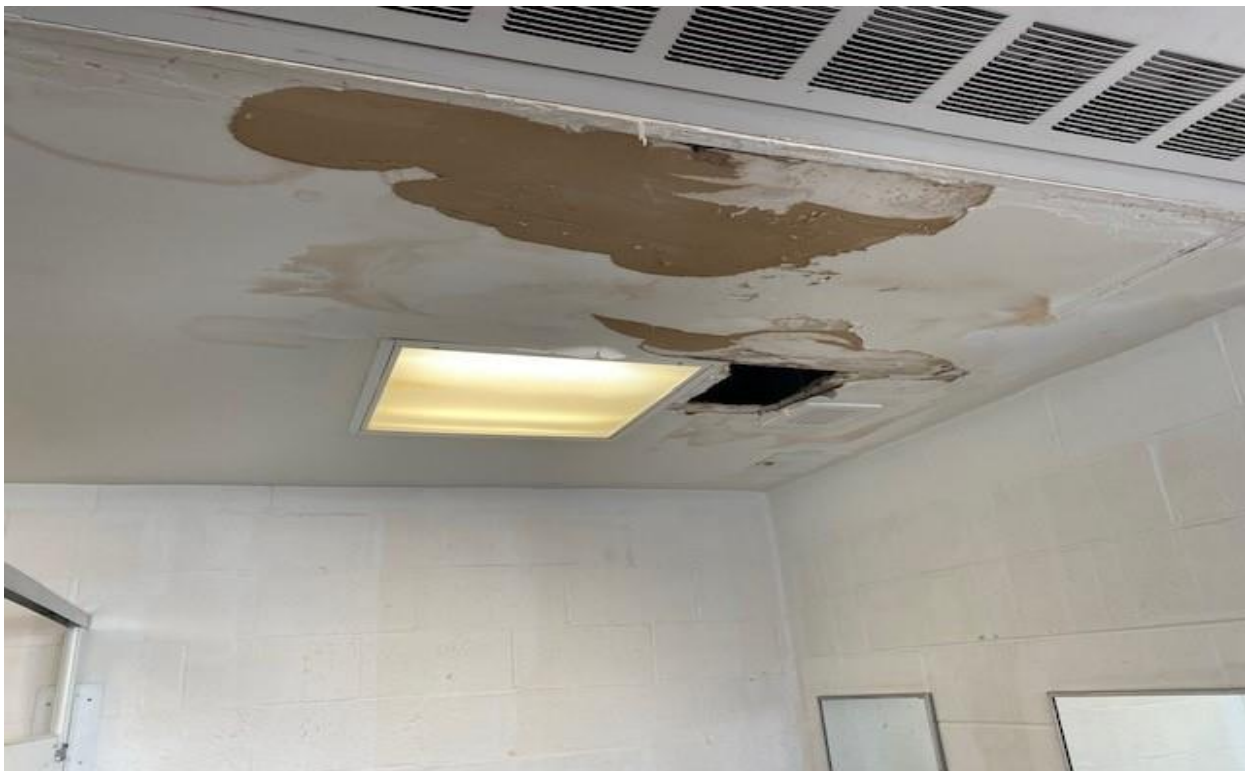
Photo #11: Internal moisture damage inside the girl's locker room.

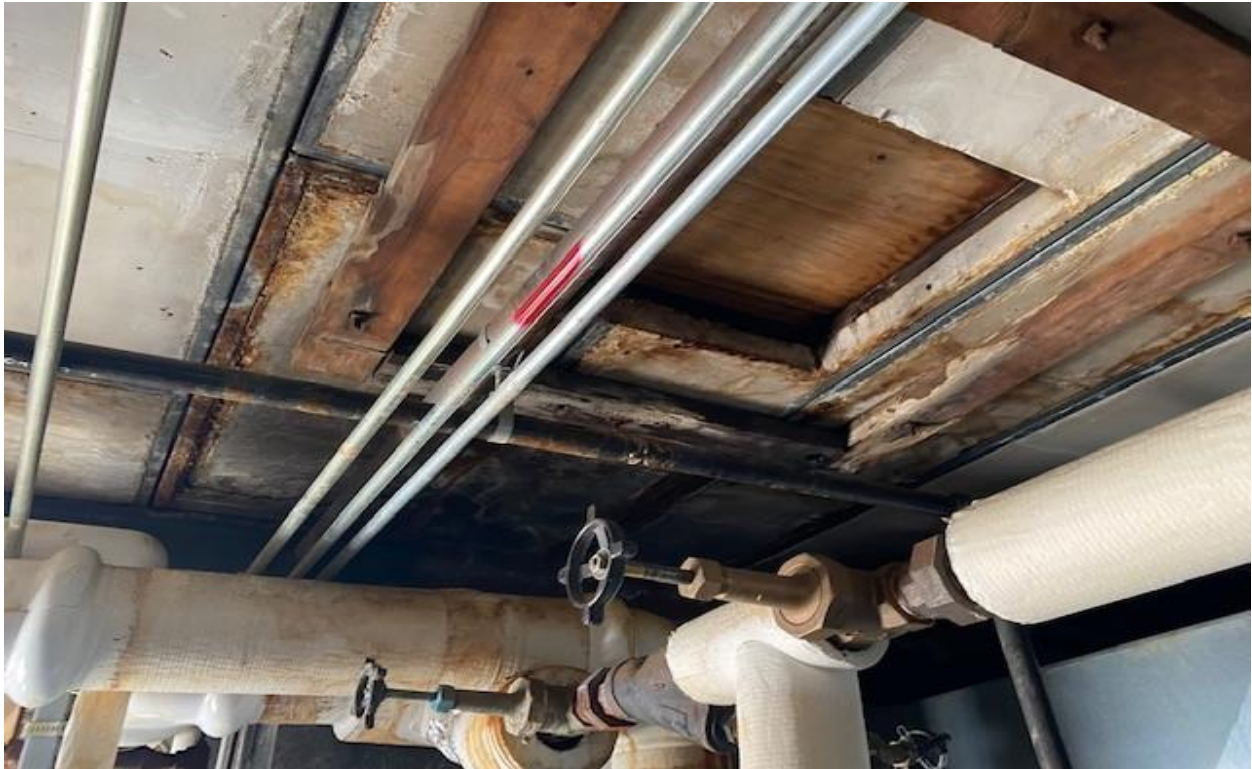
Photo #12: Internal moisture damage inside the girl's locker room penthouse.

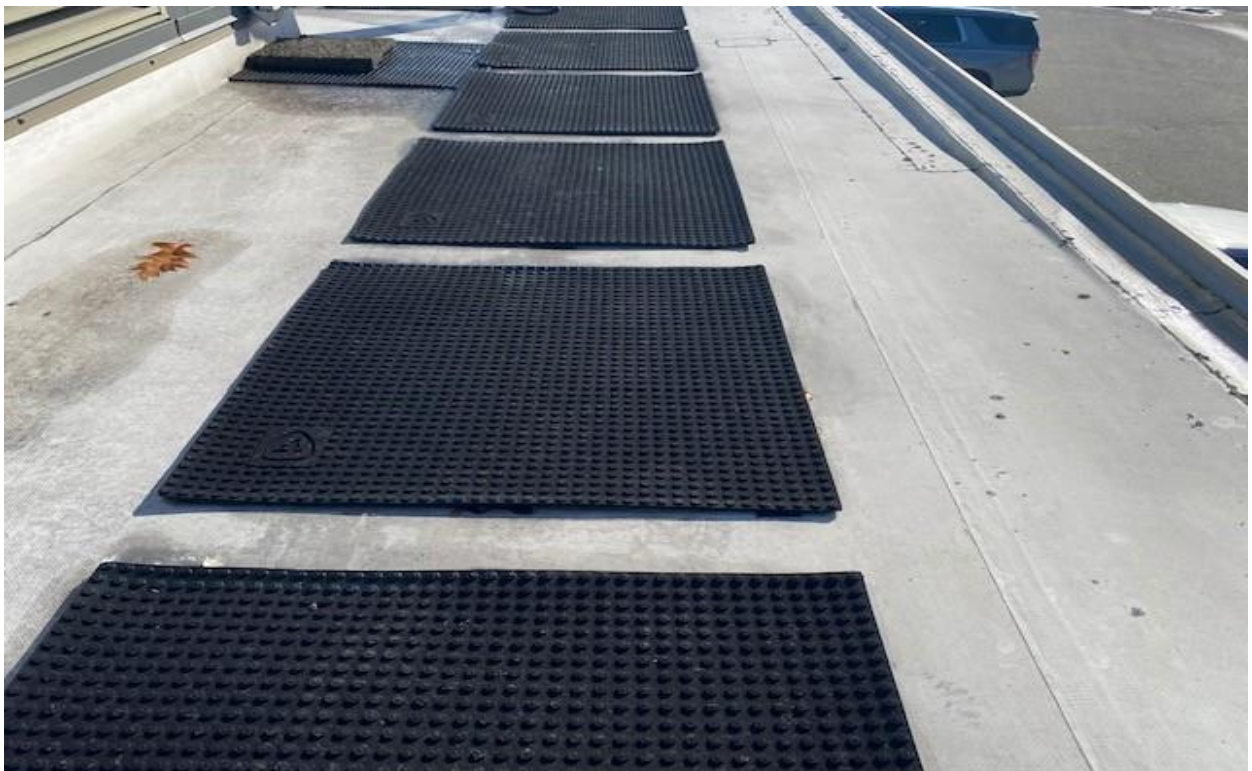
Photo #13: The black non-slip walk-pads have expedited the breakdown of the TPO membrane in the locations where they were originally installed.

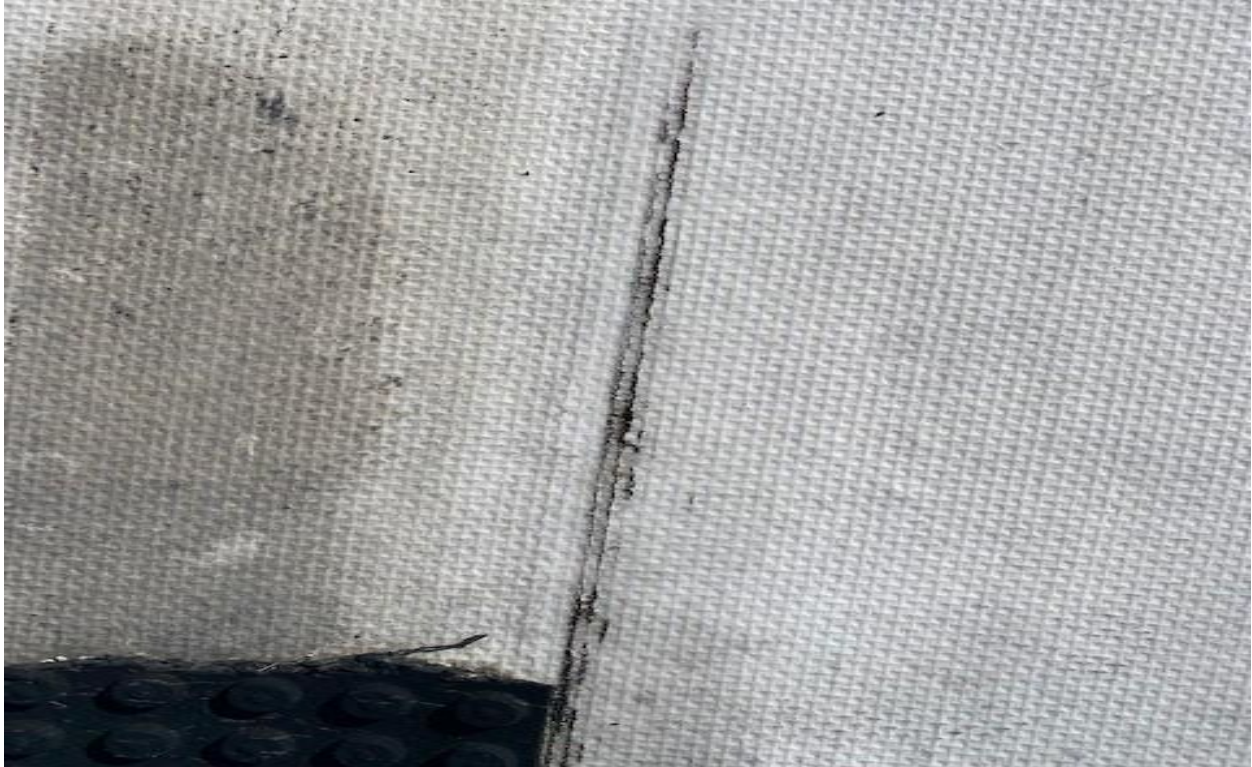
Photo #14: Example of deteriorated seam at edge of walk-pad.

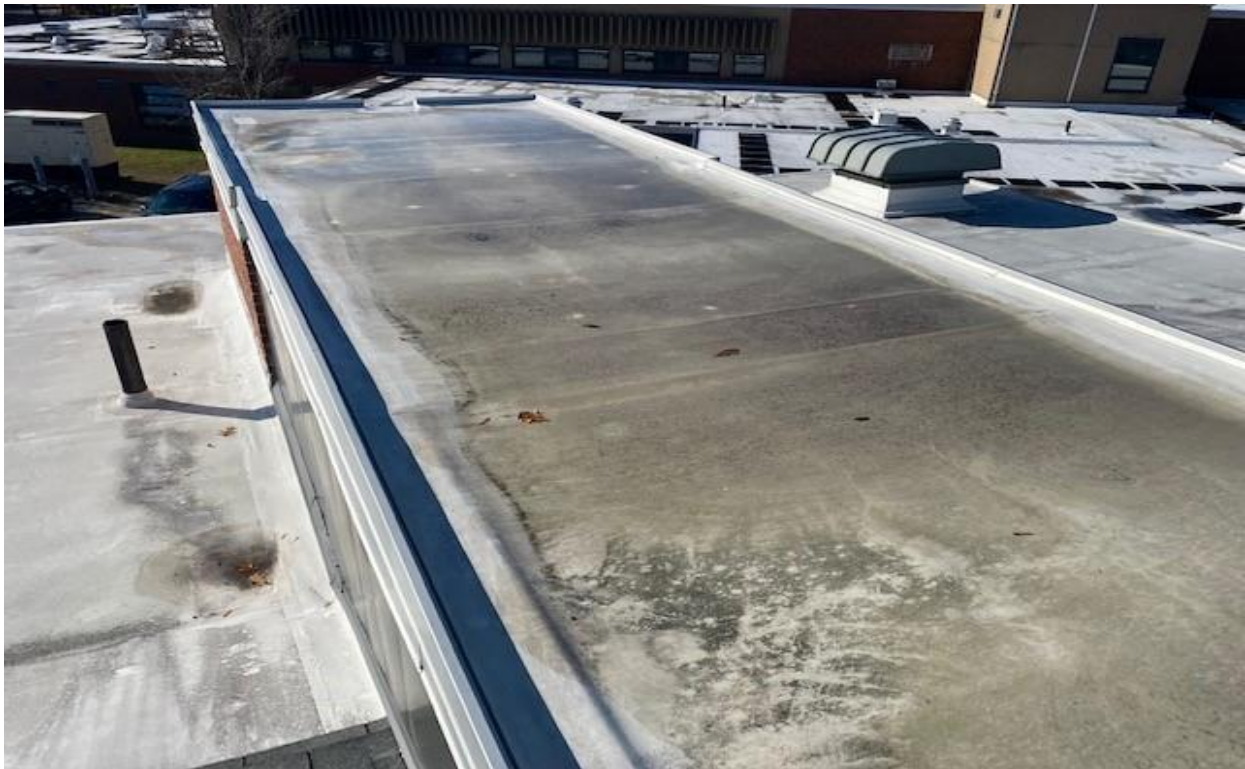
Photo #15: The ponding water on the low-sloped roof portions over the gym with help expedite the deterioration of the TPO membrane.

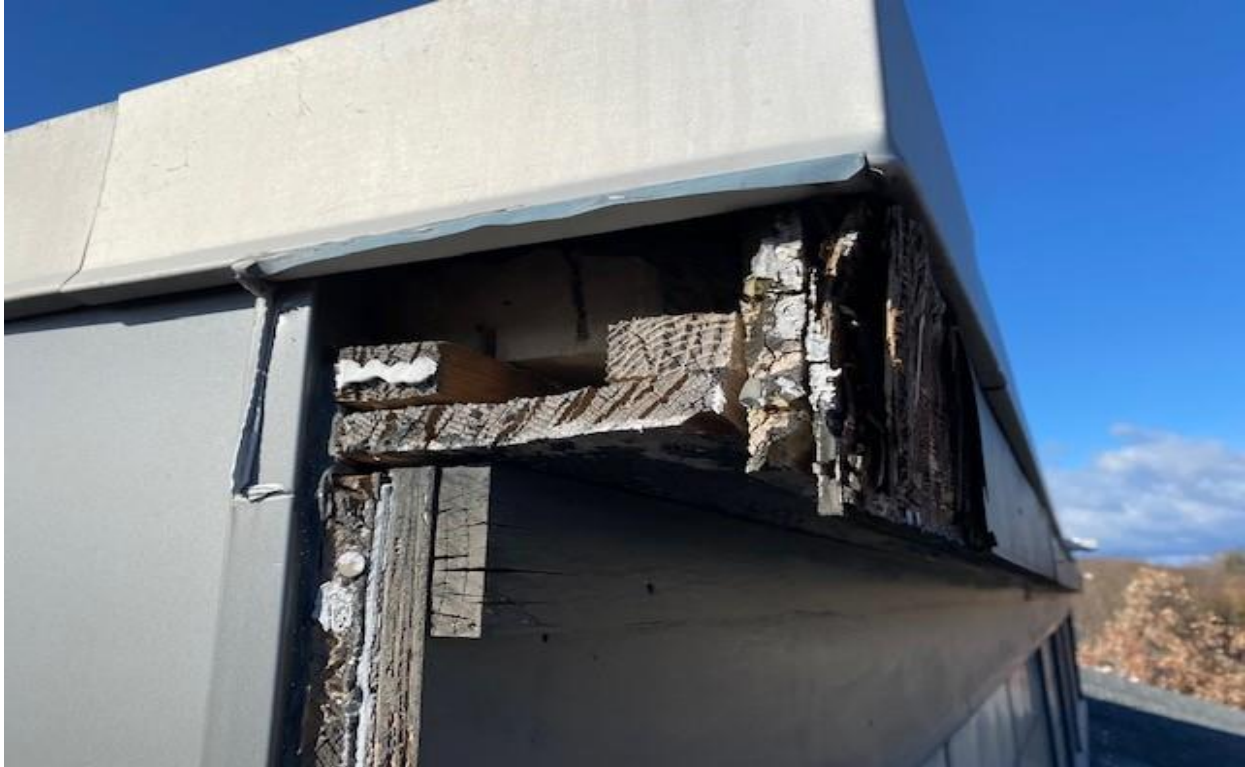
Photo #16: Missing metal edge fascia and wall cladding has compromised wood blocking at a severe leaking location showing up inside the gymnasium.

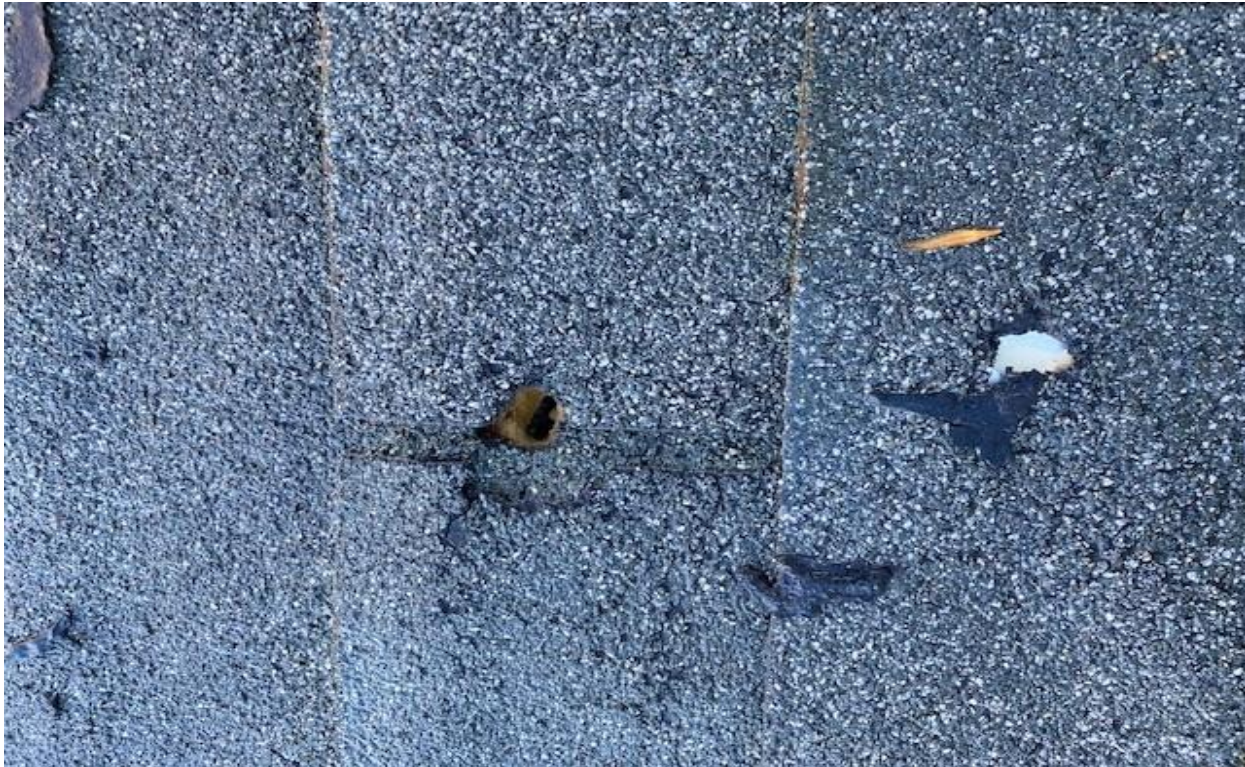
Photo #17: All the singles on the gymnasium should be replaced. There is a 15' x 25' section that is in terrible shape and should be replaced as soon as possible.
